ENVIRONMENTAL
MANAGEMENT
SYSTEMS, INC.

5 November 2020
Report # 19-0054-02

REGARDING: Winter Evaluation for feasibility of onsite wastewater treatment, HDSE Sewer System Association, Aurora State Airport, adjacent to Keil Rd. NE and Hubbard Cutoff Rd. NE, Aurora, OR 97002. T: 4S, R: 1W, Sec: 11, T.L: 800, 17.79 Acres

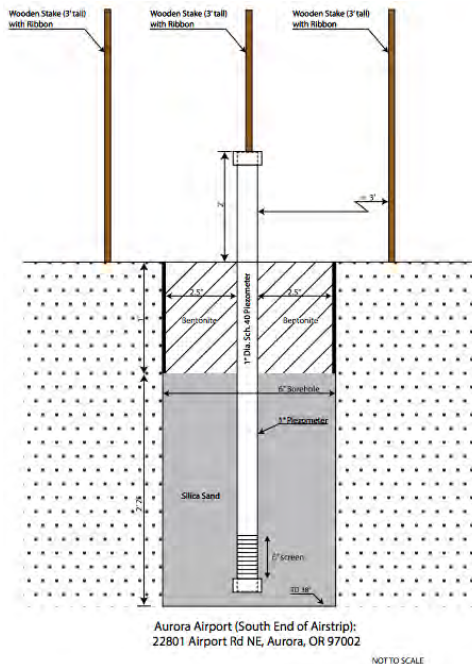
Figure 1. Piezometers were installed approximately 3 feet below grade and pressure sensors were hung from the top of the pipe. The well was sealed with bentonite clay.

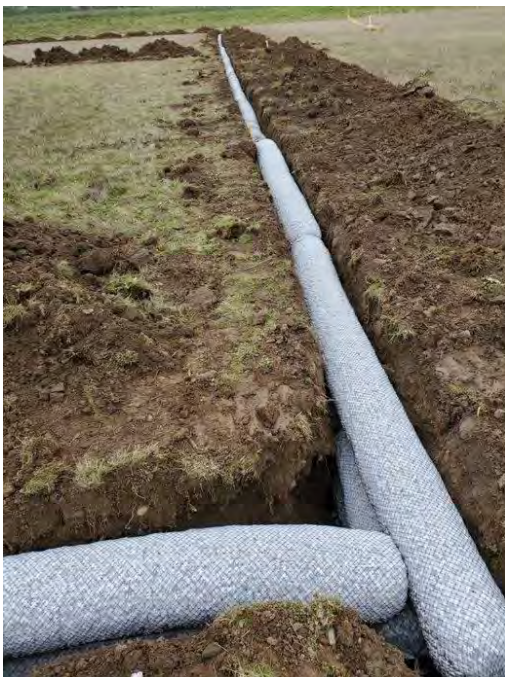
The tile dewatering system was completed on January 23rd, 2020. During each site visit, water was observed flowing from the field collection tile into the outfall pipes. Water was also observed draining from the outlet of the pipe and discharging to the swales near the east and west property lines. Prior to the installation of the TDS, ten out of twelve wells had a high-water table of 12" or less from the surface. After the installation of the TDS, only seven out of twelve wells had a high-water table, and only for relatively short periods during significant rain events. The TDS is functioning as designed and has contributed to lowering the water table.

Figure 3 –Tile dewatering trenches were installed 15-52 inches below grade and filled with 12" EzFlow bundles. 4" pipes at the bottom of the trench sloped are at 0.2-0.4%.

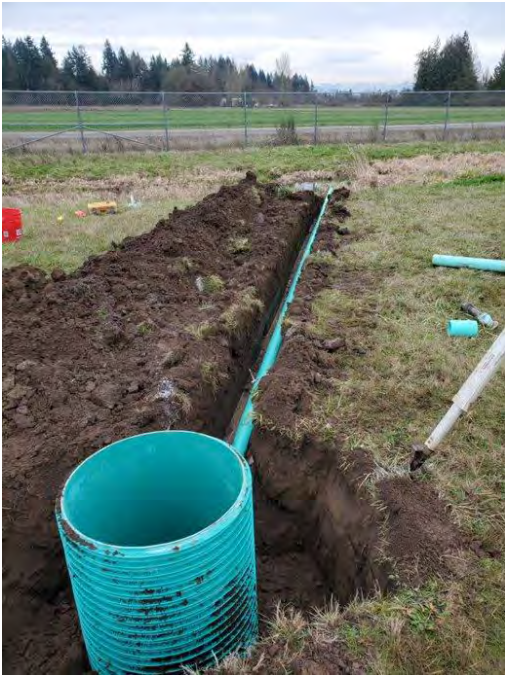
Figure 4 –24" silt traps were installed at the inlet end of each tight line outfall, which discharged toward existing drainage swales on the site. Photo taken facing west toward the west property line (fence) with Hubbard Cutoff Rd. NE in the background.
