## **Airport Pavement Assessments**

Pavement  
Evaluation/  
Maintenance  
Management Program  
2018

Aurora State  
Airport

**2018 Pavement Evaluation / Maintenance  
Management Program**

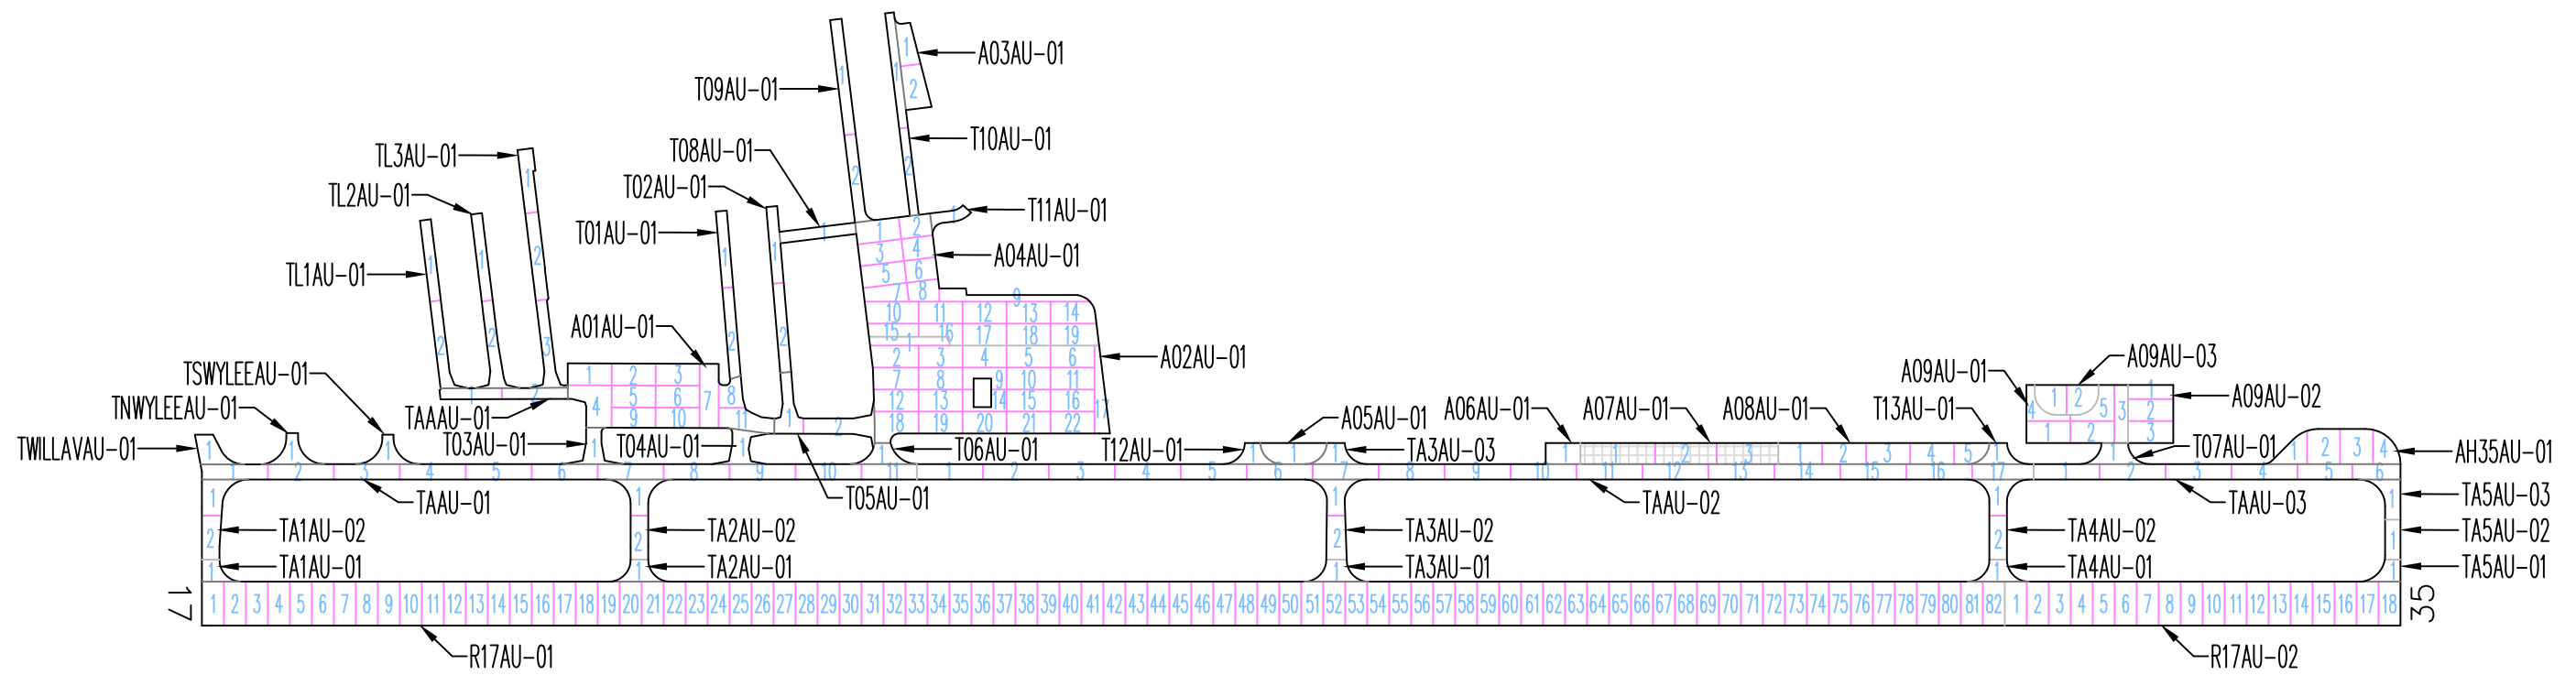
Figure AU-2. Pavement Branch, Section and Sample Unit Layout.  
Aurora State Airport

The pavements at your airport were divided into branches, sections and sample units in accordance with the methodology outlined in the current edition of ASTM D5430, *Standard Test Method for Airport Condition Index Surveys*. The branches, sections and sample units established at your airport are shown in Figure AU-2. A Branch Condition Report showing all branches, their associated areas, and their area-weighted average condition is provided in Appendix 1. Additionally, the Appendix 2 Section Condition Report provides information used to define each branch and section in the PAVER database.

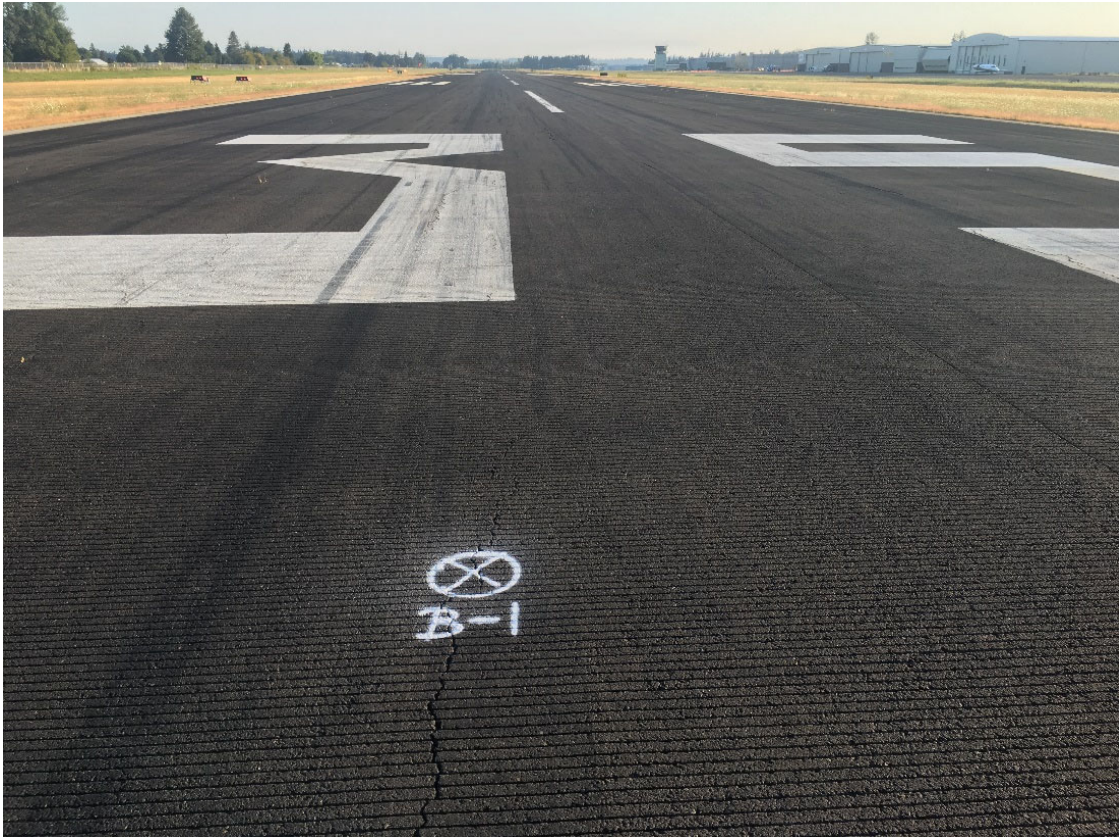
**Core B-1 (RW 17-35 8' West of Centerline, Station 56+81, FWD 26)**

**B-1 (Pavement Core Sample, 8.75 in.)**

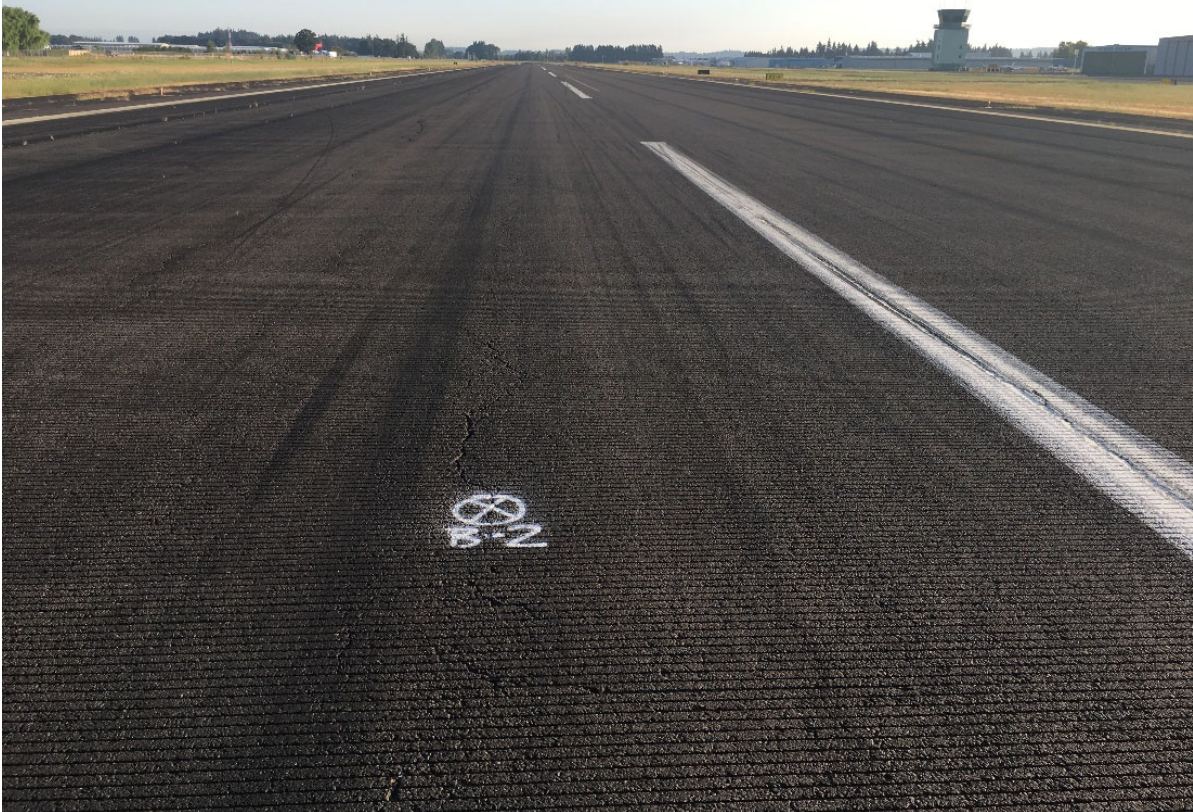
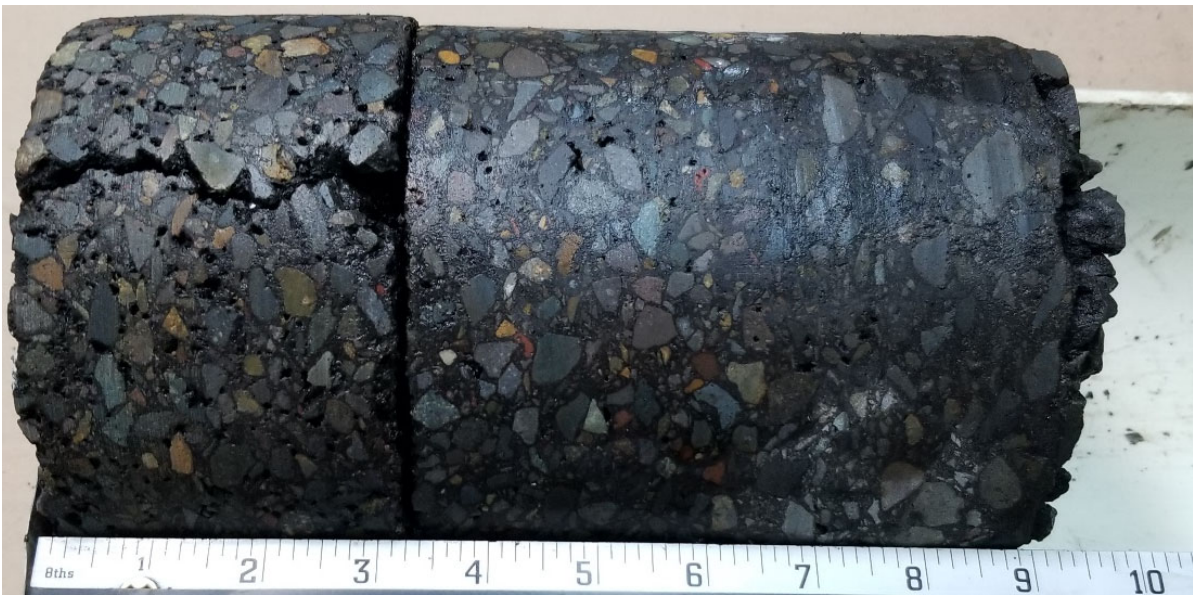
**Core B-2 (RW 17-35 8' West of Centerline, Station 39+51, FWD 16)**

**B-2 (Pavement Core Sample, 9.0 in.)**

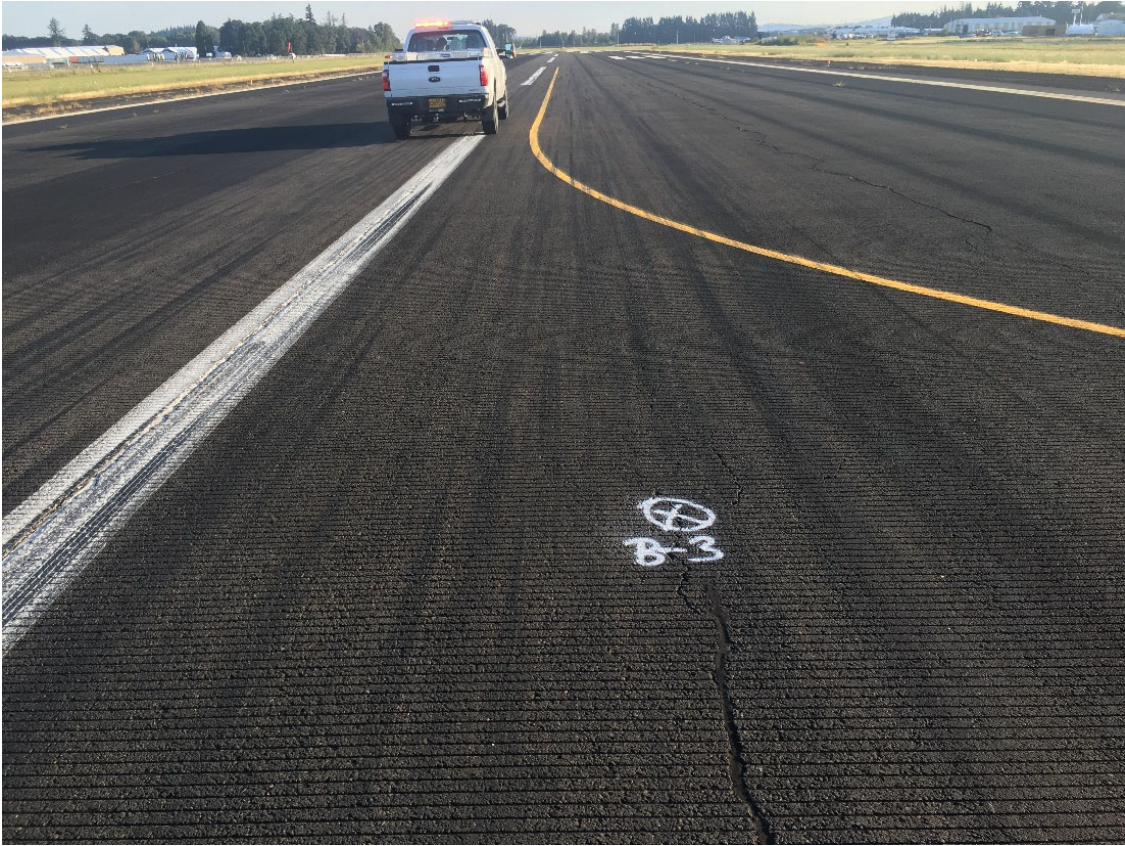
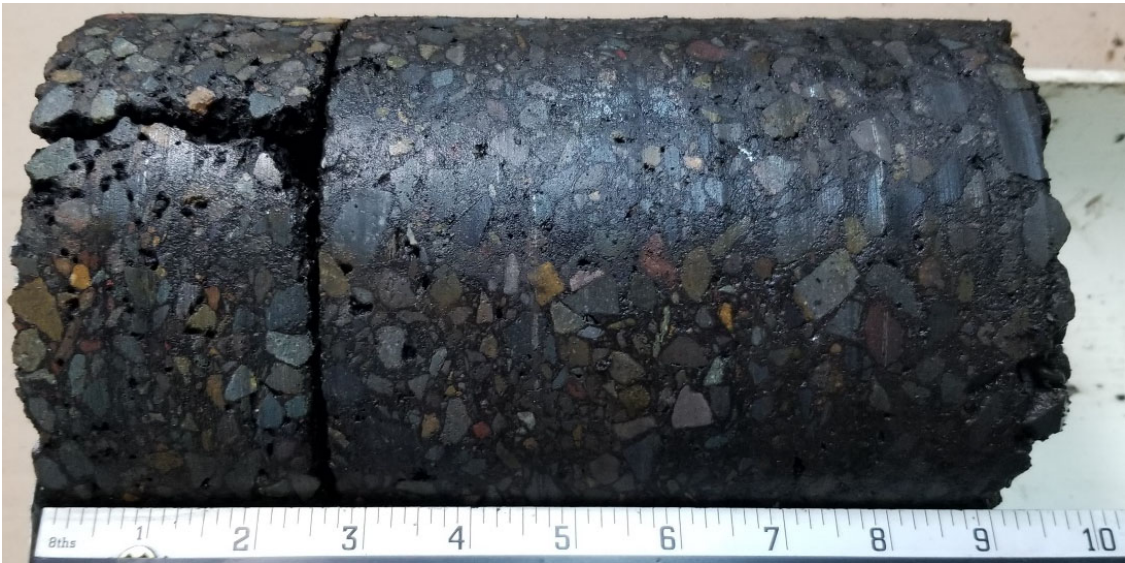
**Core B-3 (RW 17-35 12' East of Centerline, Station 19+41, FWD 32)**

**B-3 (Pavement Core Sample, 9.0 in.)**
