ENVIRONMENTAL
MANAGEMENT
SYSTEMS, INC.

5 November 2020
Report # 19-0054-02

REGARDING: Winter Evaluation for feasibility of onsite wastewater treatment, HDSE Sewer System Association, Aurora State Airport, adjacent to Keil Rd. NE and Hubbard Cutoff Rd. NE, Aurora, OR 97002. T: 4S, R: 1W, Sec: 11, T.L: 800, 17.79 Acres

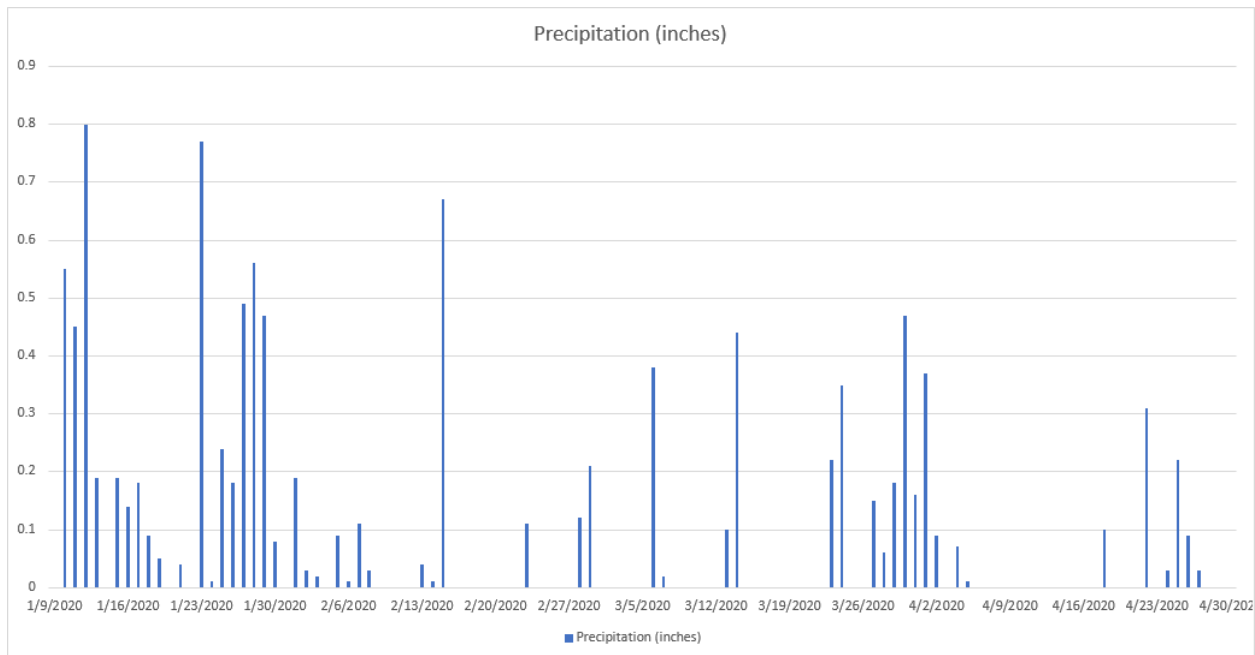
Figure 2 –Daily precipitation (inches) from the Aurora State Airport weather station (June 9th – May 1st).

Table 3 shows total precipitation for the months of January through April 2020. Although the month of January was above normal, February, March, and April were drier than normal. The expected normal and the measured precipitation for the months of the study were totaled, and overall, the precipitation was found to be 70% of historic normal. Daily precipitation levels are graphed in Figure 2, below.

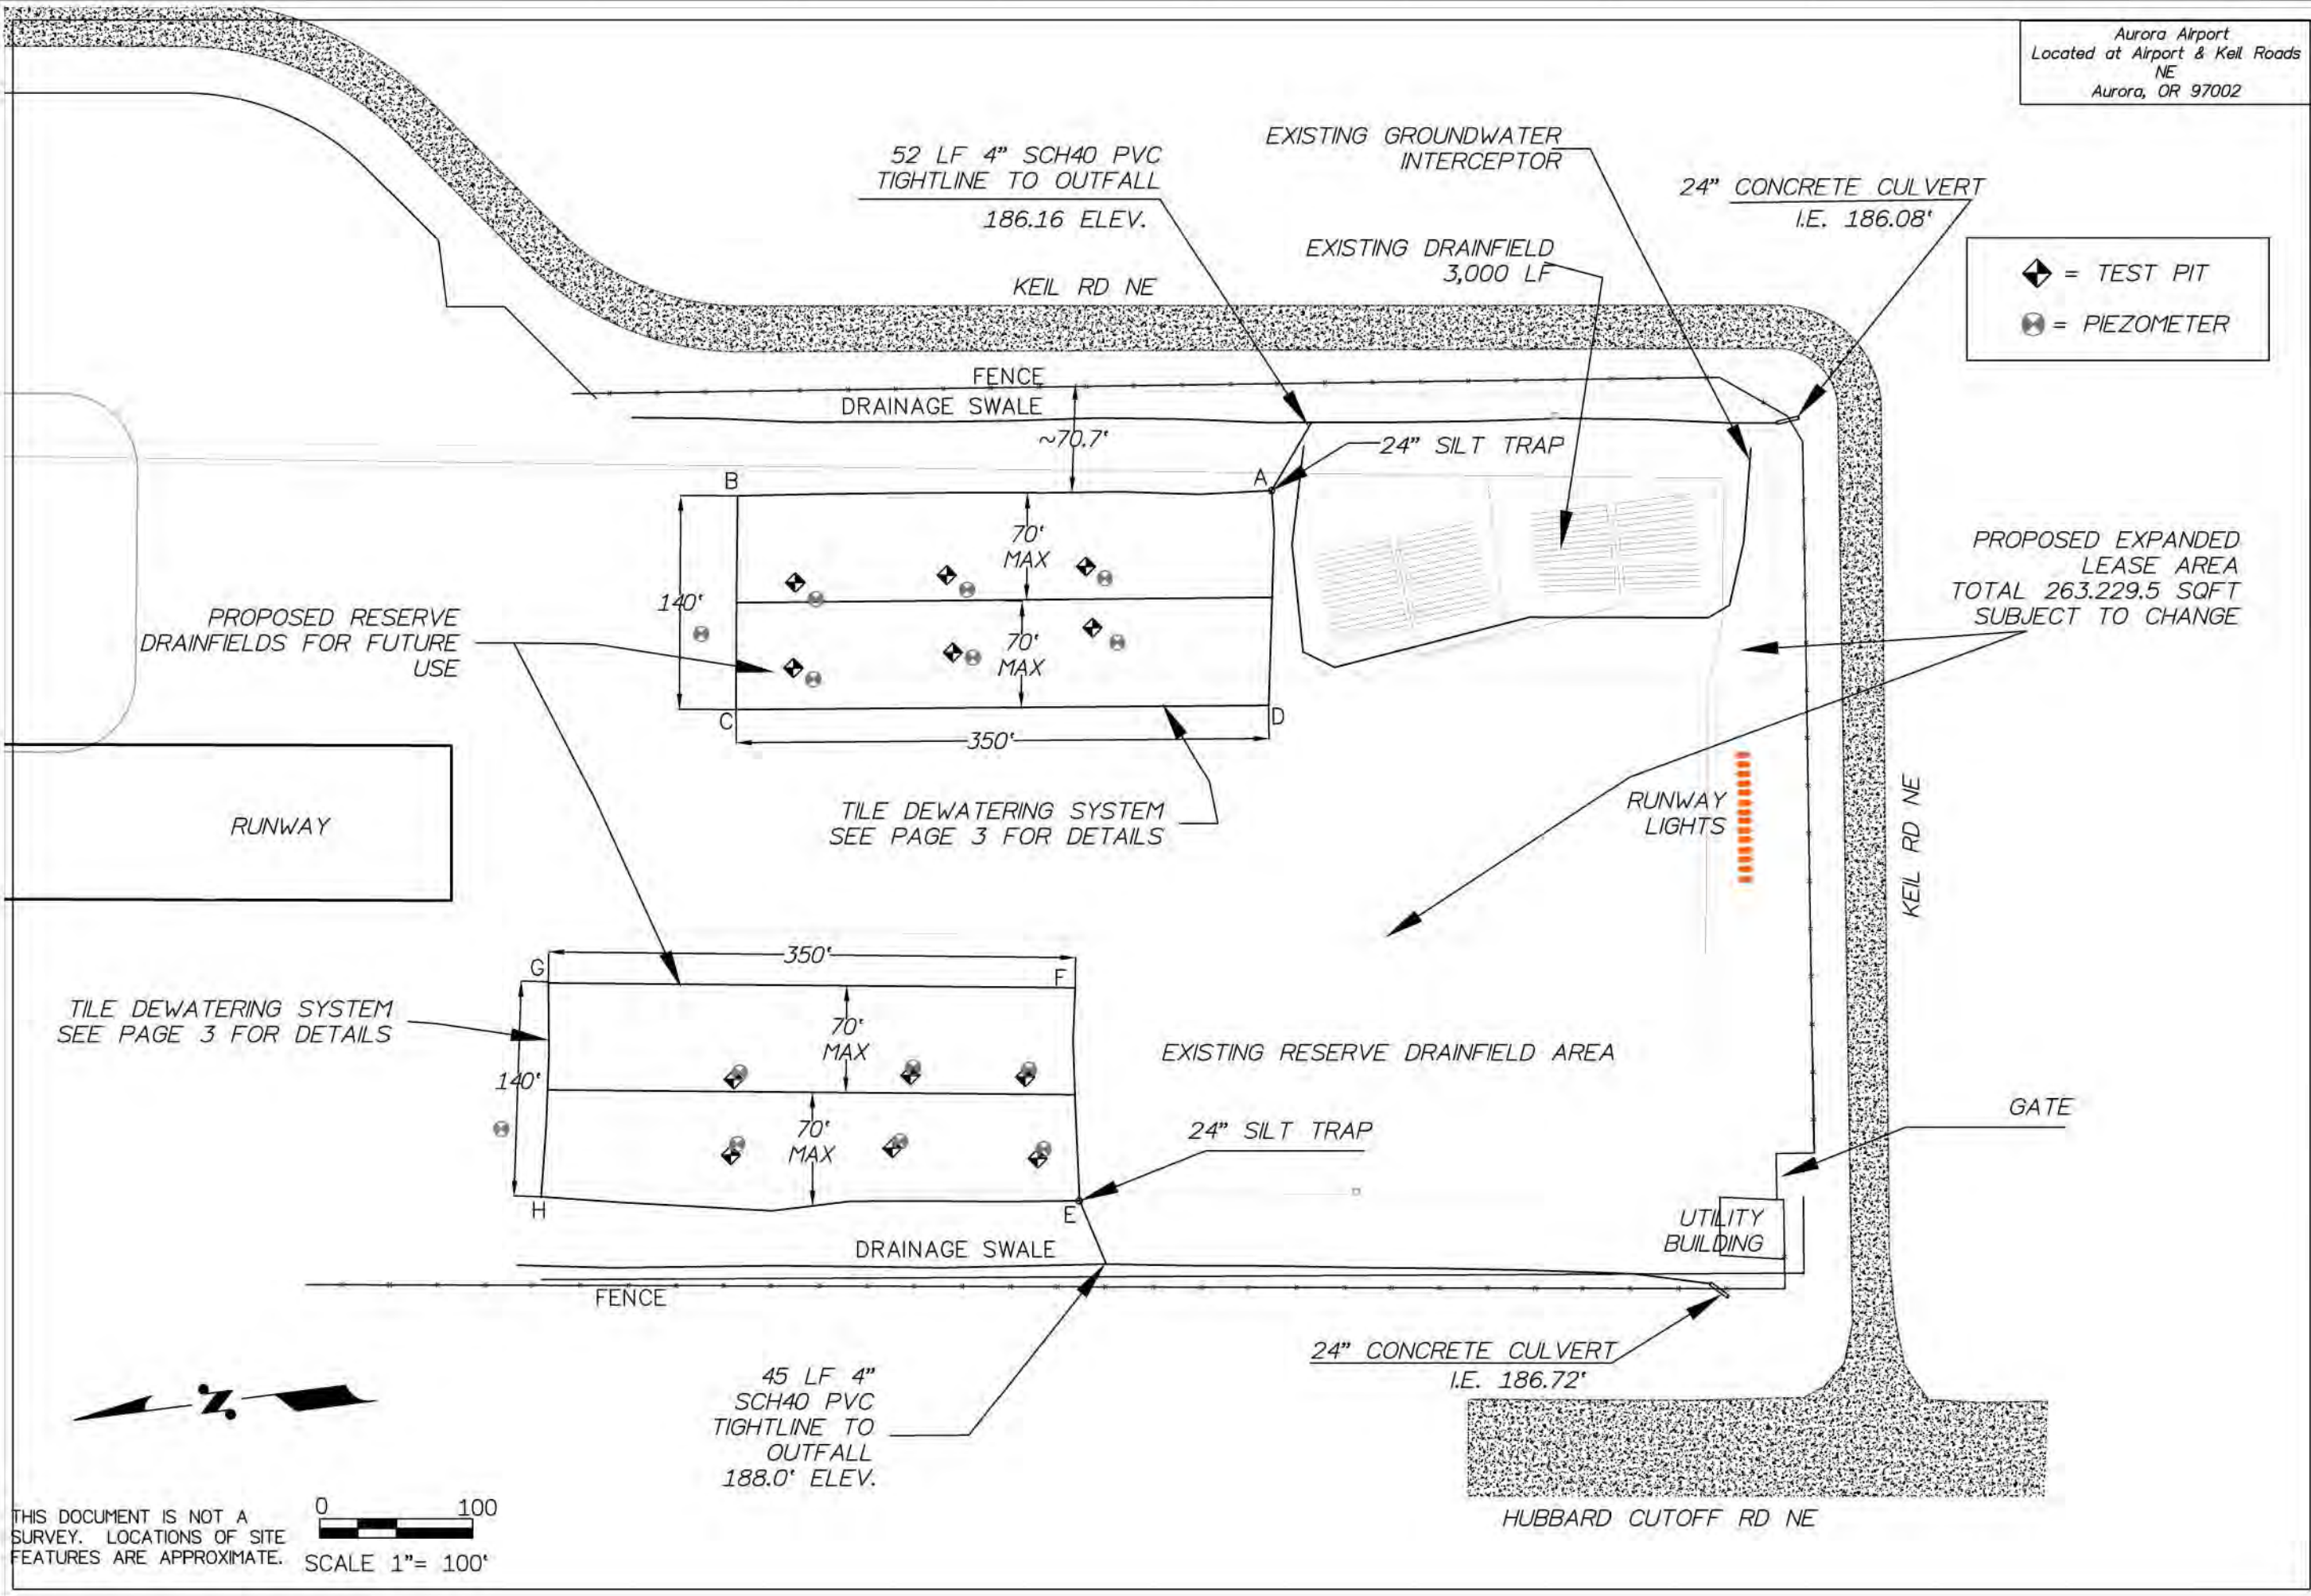
19-0054	AABC-HD AVIATION	12/10/2019	2 OF 3
T: 4S, R: 1W, Sec 2 & 11, TL: 200, 203, 400, 401, 800, 900 & 1600		SITE PLAN	
CHECKED:	DRAWN:	ENVIRONMENTAL MANAGEMENT SYSTEMS, INC.	
		4080 SE International Way Suite B112 Milwaukie, OR 97222 503-353-9691 360-735-1109 www.envmgisys.com

The new drainfield lease area was surveyed prior to conducting the study. Enough area was included for two new drainfields and reserve areas to support a design flow of approximately 10,000 gpd, thereby doubling the existing system's capacity. Twelve test pits were dug across the site in the summer of 2019, with six on the eastern proposed drainfield area, and six in the western proposed drainfield area. Various depths of the (at least) 27 year old fill were observed over the native silt loam in the 6 eastern test pits dug on the site (TP's 5-10).

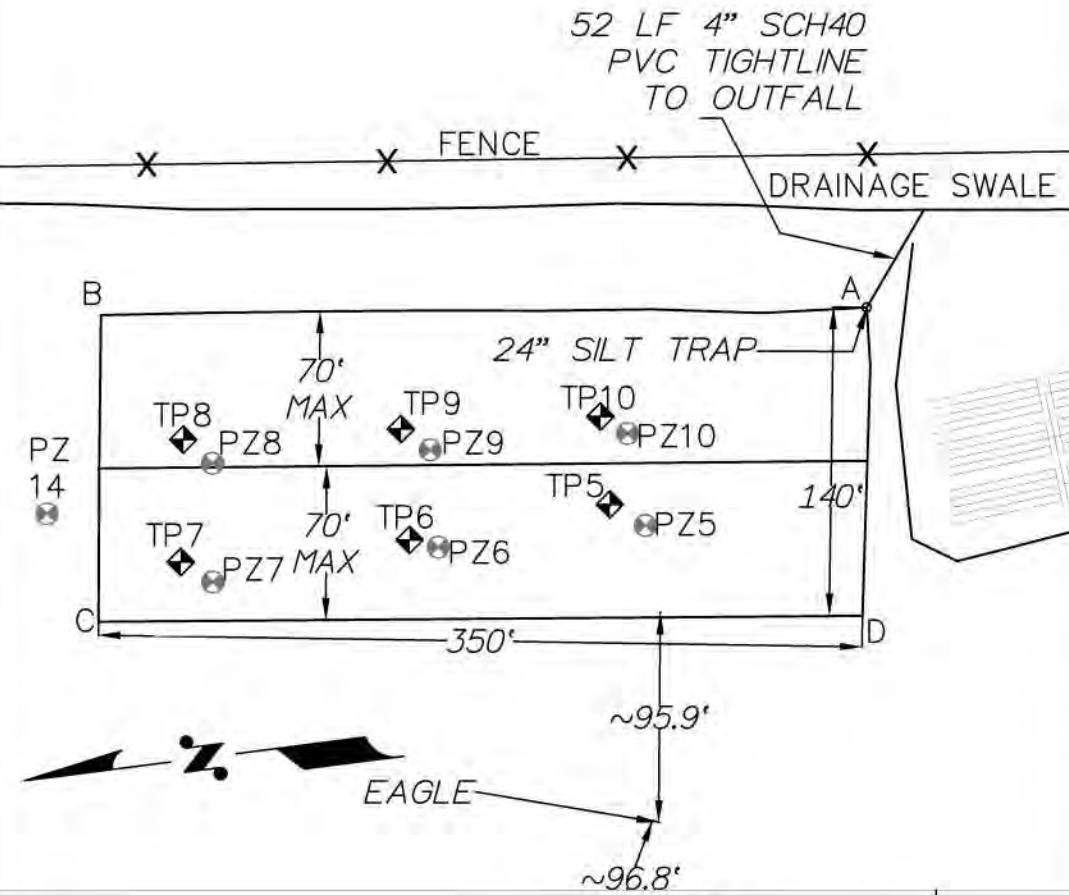
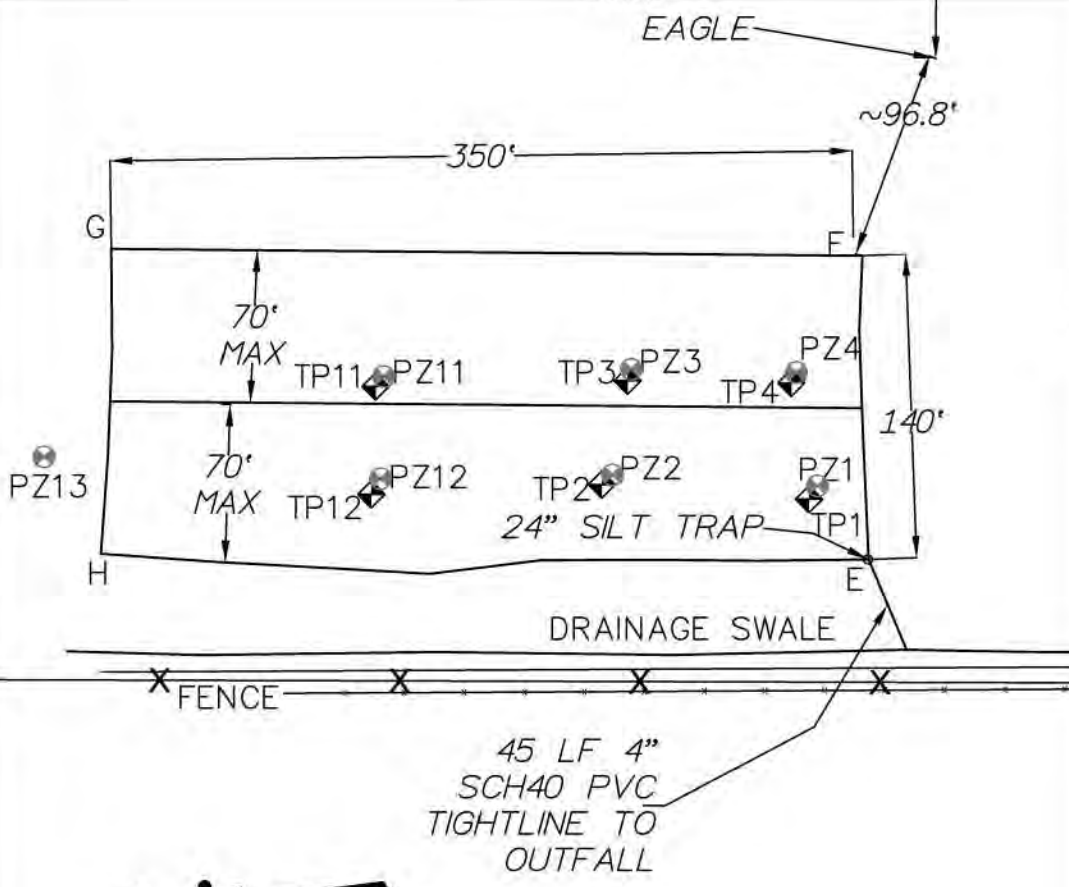
The tile dewatering system was completed on January 23rd, 2020. During each site visit, water was observed flowing from the field collection tile into the outfall pipes. Water was also observed draining from the outlet of the pipe and discharging to the swales near the east and west property lines. Prior to the installation of the TDS, ten out of twelve wells had a high-water table of 12" or less from the surface. After the installation of the TDS, only seven out of twelve wells had a high-water table, and only for relatively short periods during significant rain events. The TDS is functioning as designed and has contributed to lowering the water table.

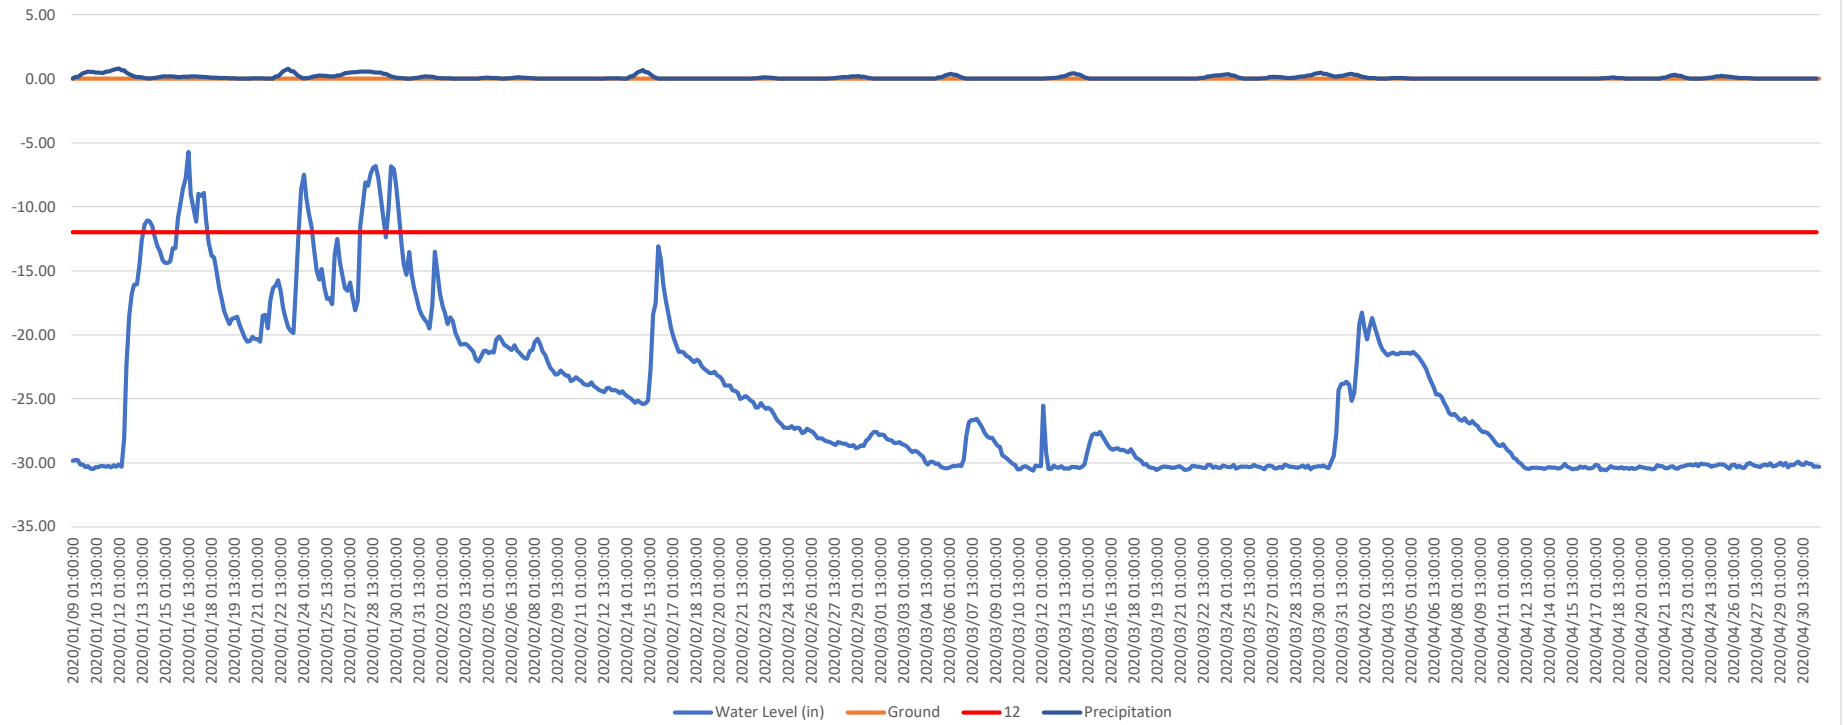
Temporary Water Table - PZ3

Daily precipitation is graphed along with water table levels in the enclosed hydrographs. All shallow water table readings occurred in January, which had 120% of normal rainfall, except for Pz1, which had one reading on 2/16/2020, and Pz12, which had three readings on 2/16/2020. 0.67 inches of rainfall occurred on the previous day (2/15/2020). The longest duration that any well had a shallow water table of 12” or less was 23 consecutive readings (about 3.8 days). See Table 6 below. In Pz1, Pz2, Pz5, Pz6, Pz10, and Pz12, the longest duration of shallow water table conditions occurred around the dates of 01/27/2020 - 01/29/2020, when approximately 1.5 inches of rain fell. On average, the water table was only above 12 inches for about 0.9 days after significant rain events. According to the standards recommended by Virginia Tech, less than 21 consecutive days of high-water table conditions is considered acceptable.
