# CULTURAL RESOURCE REVIEW AND ARCHAEOLOGY SURVEY

# AURORA STATE AIRPORT MASTER PLAN PROJECT,

MARION COUNTY, OREGON

REPORT NO. 4754

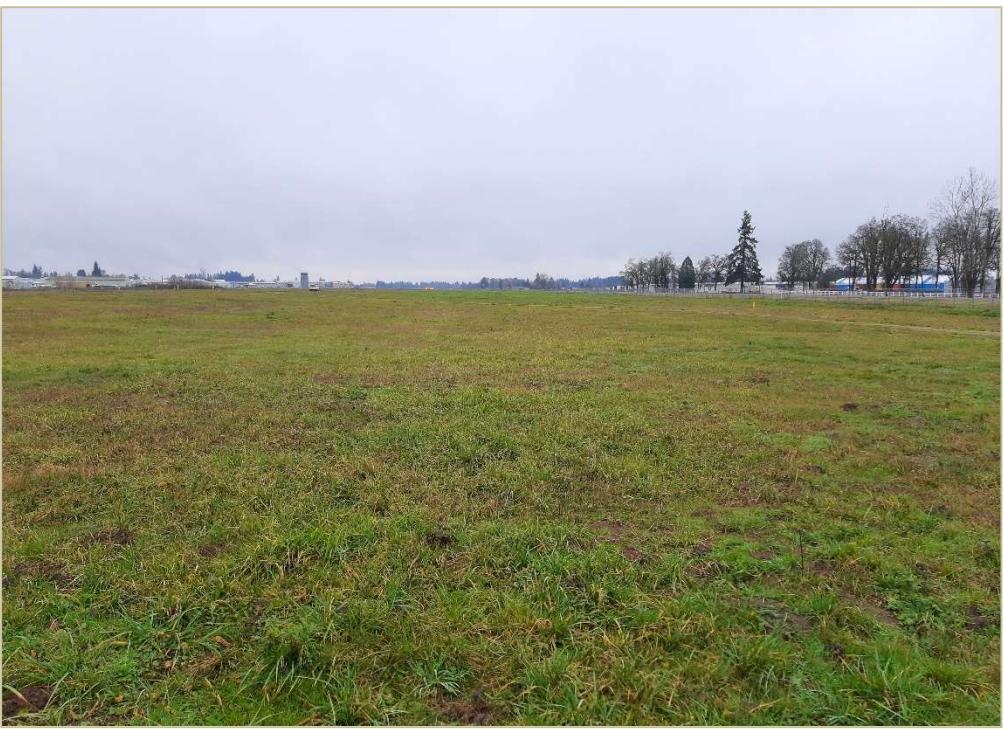
Photo 1. Overview of the northern portion of the study area, which represents the ground visibility in the non-paved and gravel-covered portions of the study area. The view is towards the south.

The study area was examined by walking transects spaced no more than 15 m (50 ft) apart. All exposed ground surfaces were carefully examined for evidence of artifacts. Mineral soil visibility was limited by vegetation cover and graveled and paved surfaces, and less than 10% of the mineral soil surface was visible throughout the study area (Figure 1; Photos 1, 2, and 3). The entire 148.4-acre study area was surveyed.

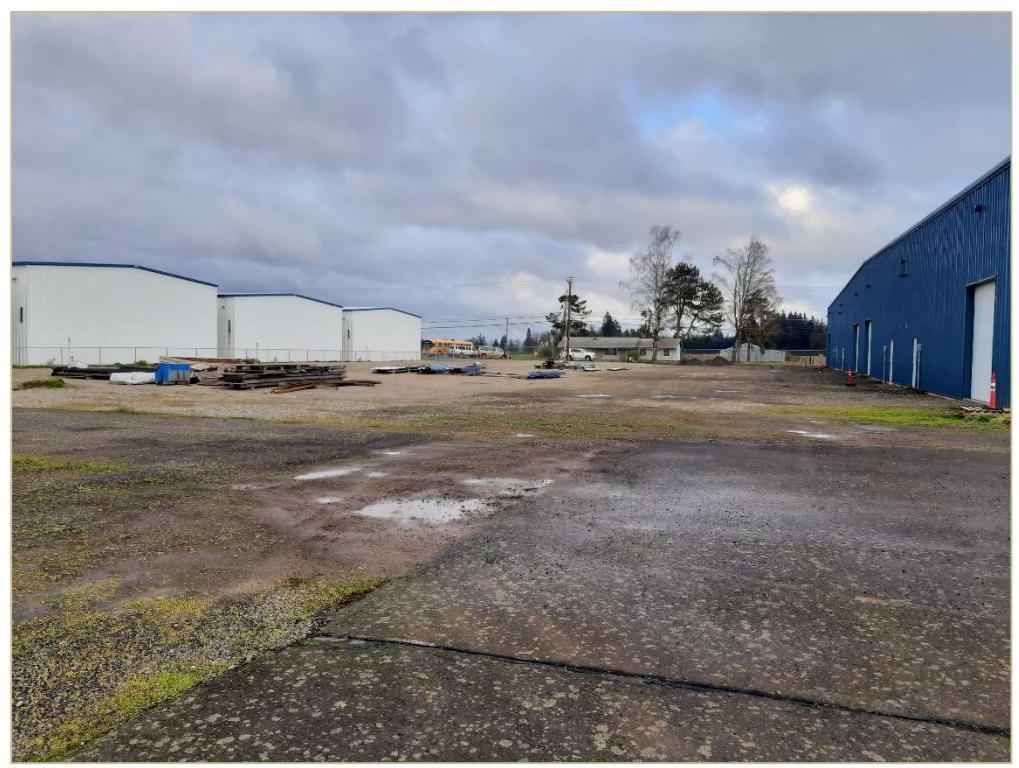
Photo 2. Overview of a paved and gravel-covered area in the eastern portion of the study area. The view is towards the east.

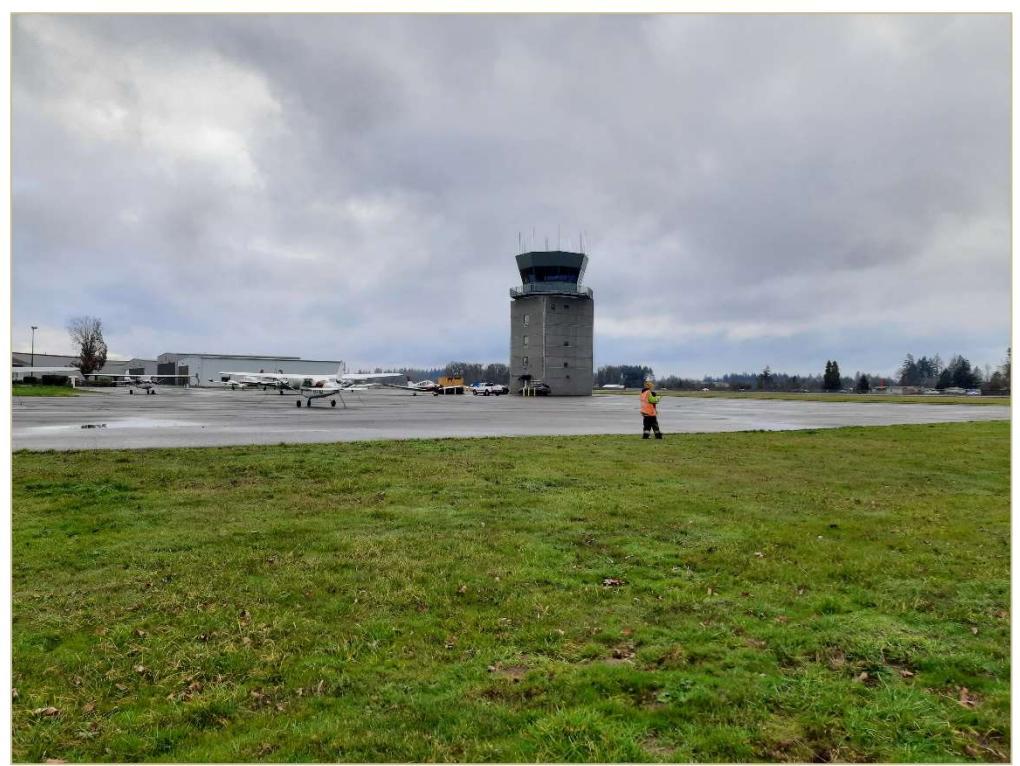
Photo 3. Overview of the grass-covered and paved area surrounding the control tower in the eastern portion of the study area. The view is towards the southwest.

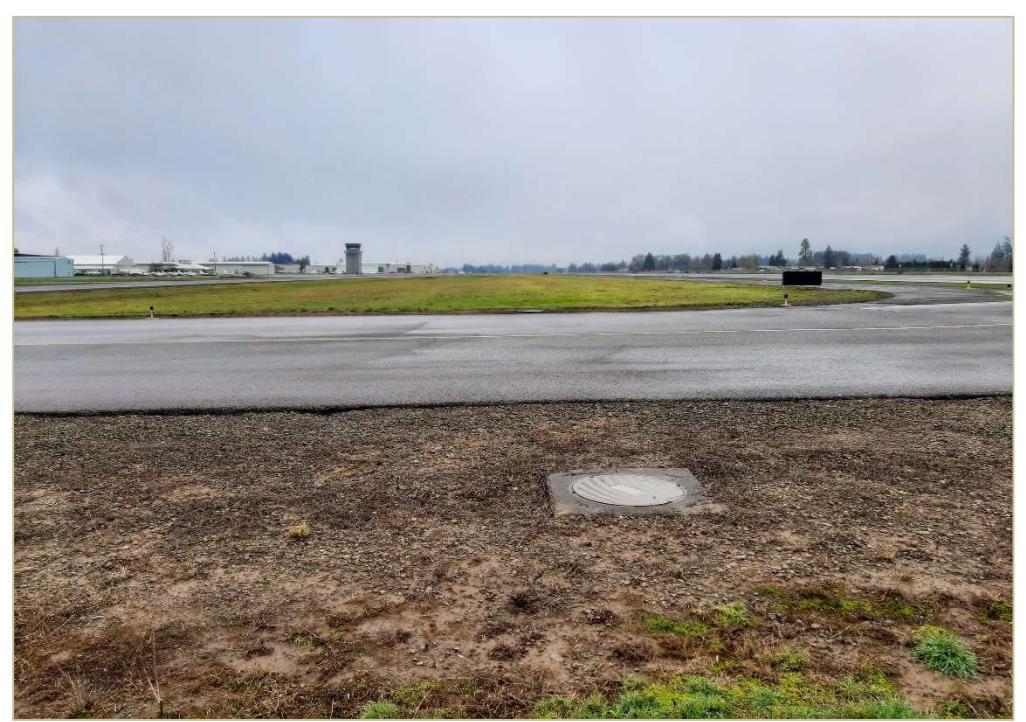
Photo 4. Overview of the central portion of the study area. The runway is visible at right and the taxi lanes are visible at left. The view is towards the south.

Much of the non-paved ground surface throughout the study area appeared to be filled and leveled. The runway and taxiway pass northeast-southwest through the study area (Photo 4). Drainage ditches were present east and west of the existing runway and several buried utilities were identified throughout the study area (Photo 5). A gravel access road passes through the northern portion of the study area. What appeared to be drain fields were identified in grass-covered areas in the north, south, and eastern portions of the study area. These areas featured visible ground disturbance with buried PVC pipes and gravel to facilitate water drainage in the area (Photo 6).

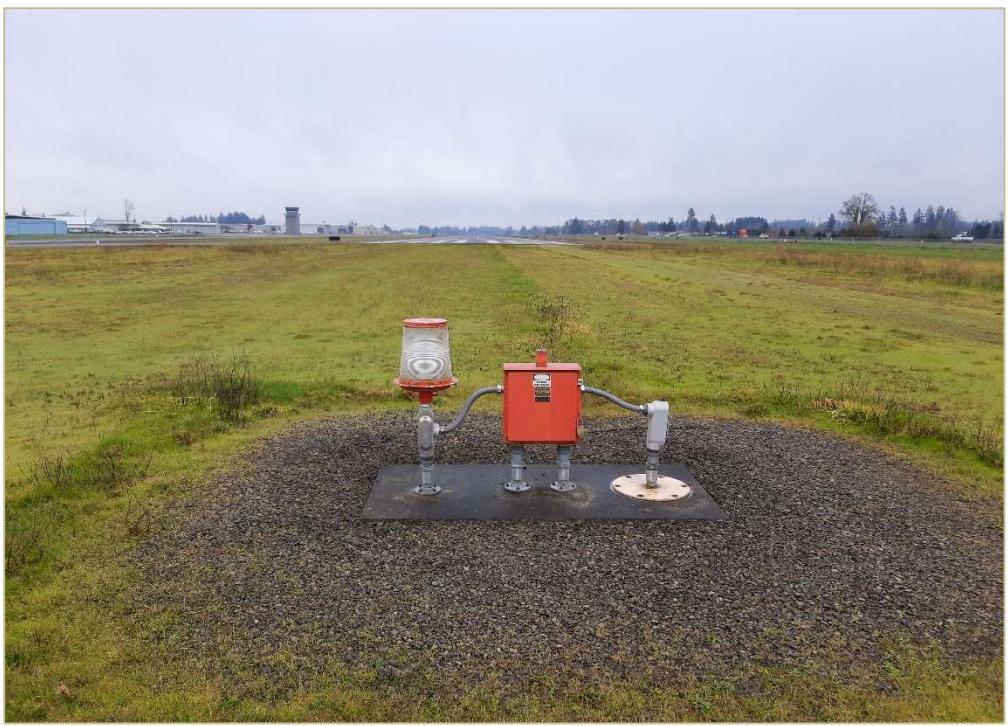
Photo 5. Example of buried utilities throughout the airport property. This light fixture is located in the northern portion of the study area. The view is towards the south.

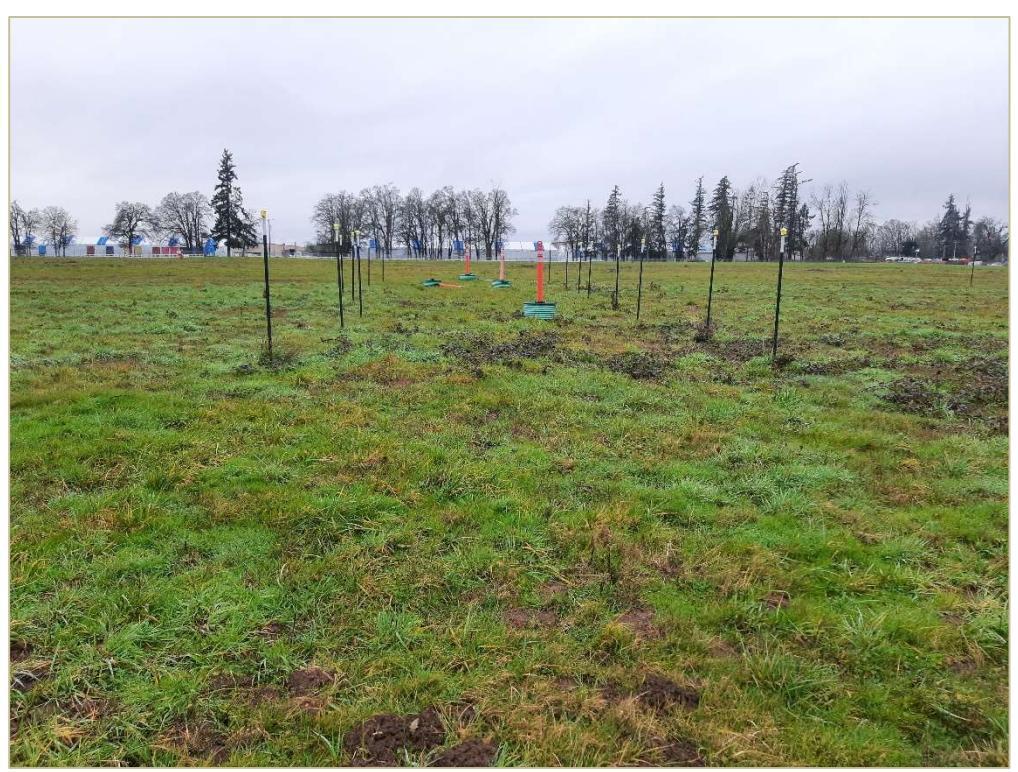
Photo 6. Overview of drain field located in the northeastern portion of the study area. The view is towards the west.

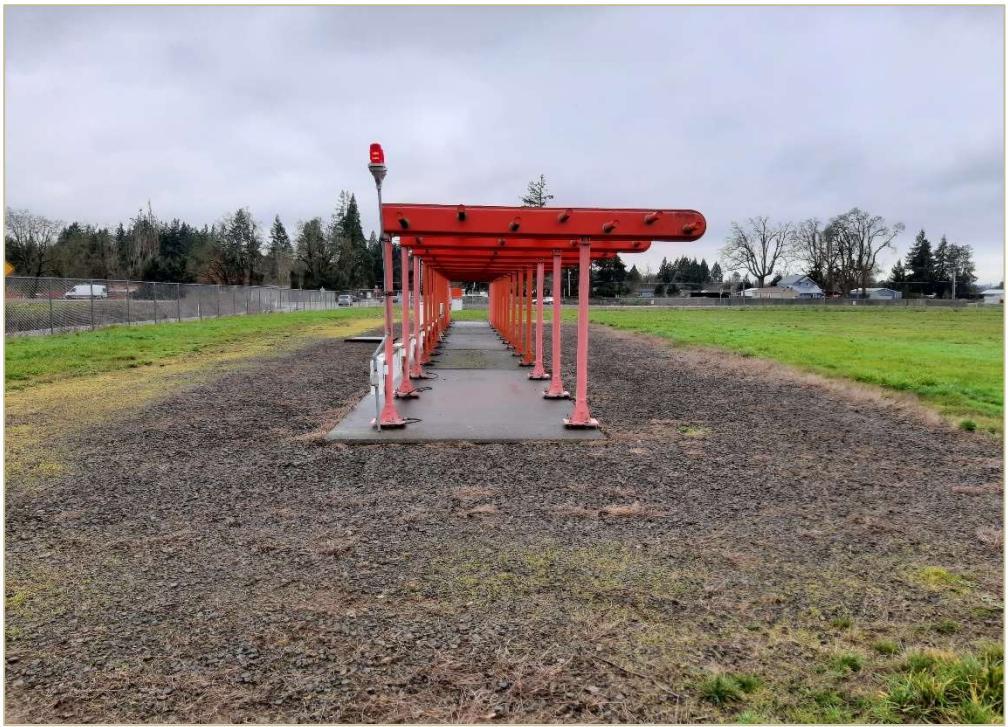
Photo 7. Overview of the light and signaling fixture located in the southern portion of the study area. The view is towards the west.

A large, paved area is located in the eastern portion of the study area that features a weather monitoring station, and a gravel pad with guide lighting is located within the southern portion of the study area (Photo 7). The easternmost portion of the study area featured large fill piles and areas that appeared to have been leveled and mechanically excavated (Photo 8).

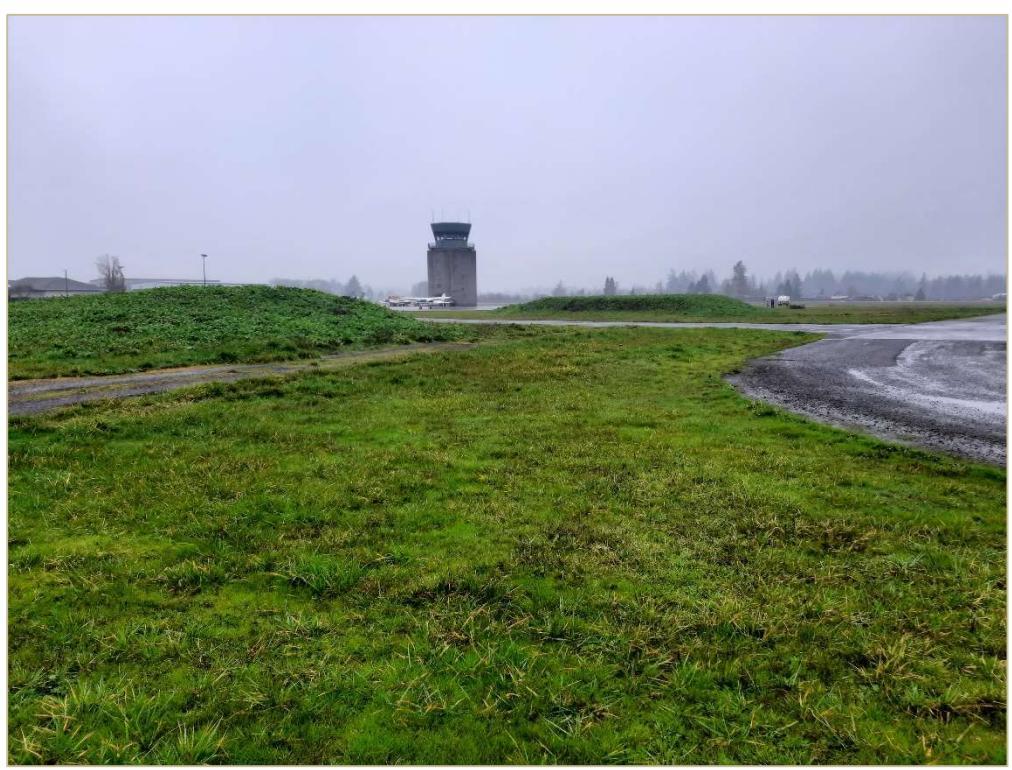
Photo 8. Overview of ground disturbance in the eastern portion of the study area. The control tower can be seen in the background. The view is towards the west-southwest.

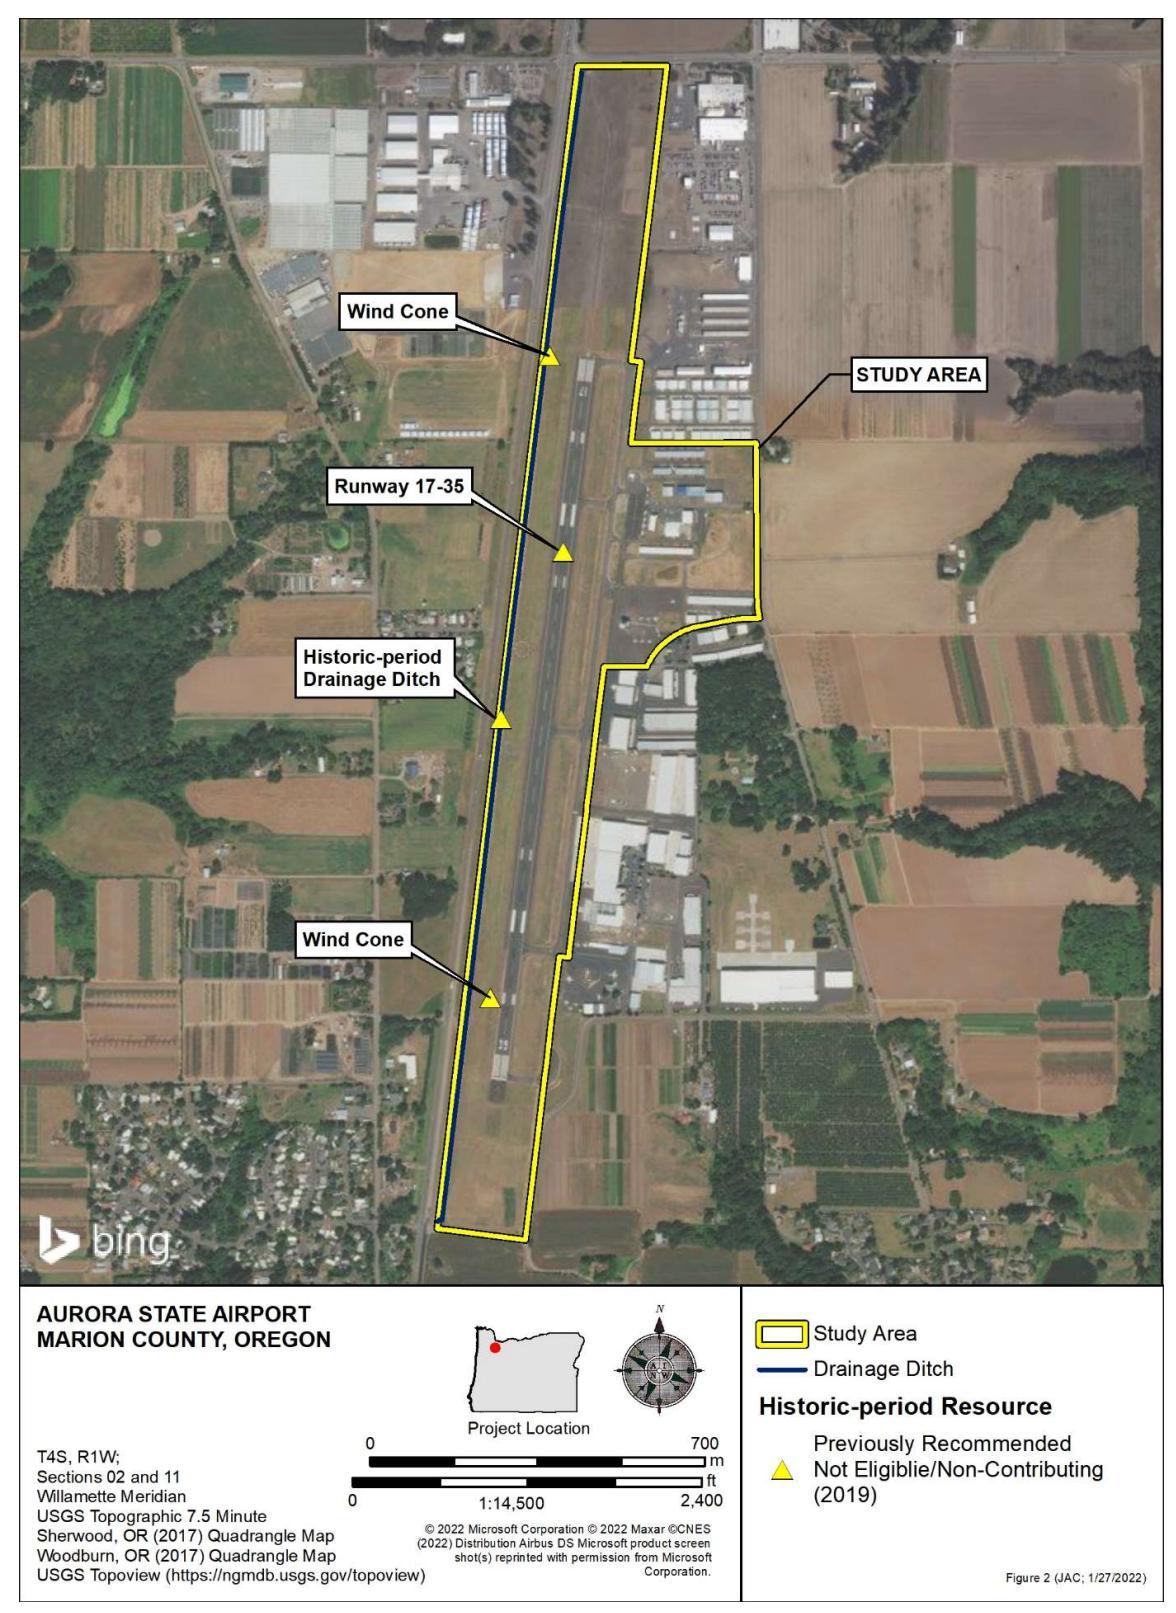
Figure 2. Four historic resources have been documented at the airport (Fortin et al. 2019). The resources were recommended to be Not Eligible/Non-Contributing.

In 2017 and 2019, AINW completed a cultural resources survey within the study area and recorded four historic resources at Aurora State Airport property: Runway 17-35, a drainage ditch, and two wind cones (Figure 2; Photos 9 and 10) (Fortin et al. 2019). The runway was constructed in 1943 as the Aurora Flight Strip. The two wind cones and the drainage ditch appear to have been constructed in 1953 when the Board of Aeronautics began to lease the airport from the Bureau of Public records. The historic-period drainage ditch parallels Runway 17/35 on the west side of the study area. The two historic-period wind cones are located east of the ditch on the north and south ends of the runway. A second drainage ditch on the east side of the runway, several storage buildings or hangars, the Aurora Aviation building, a commercial business, and the Aurora Air Tower are within the study area but are less than 50 years old (Historic Aerials 2022; Google Earth 1994).

At the recommendation of AINW, the FAA determined that the four historic resources at Aurora State Airport are not individually eligible for listing in the NRHP, and that they are unlikely to contribute to a potential historic district at the airport. Runway 17/35 has been significantly modified since it was constructed in 1943 for emergency use, and changes to the Aurora State Airport property during the late twentieth century have diminished the runway's historical integrity of design, setting, materials, workmanship, feeling, and association. Similarly, the expansion of the Aurora State Airport property and FBO facilities and improvements made during the modern period detract from the historical appearance and integrity of the two wind cones and drainage ditch that were constructed circa 1953. AINW's summary report (Fortin et al. 2019) documented historic resources in a baseline table, which is no longer an acceptable form of historic resources documentation for most projects that are reviewed by the Oregon SHPO.

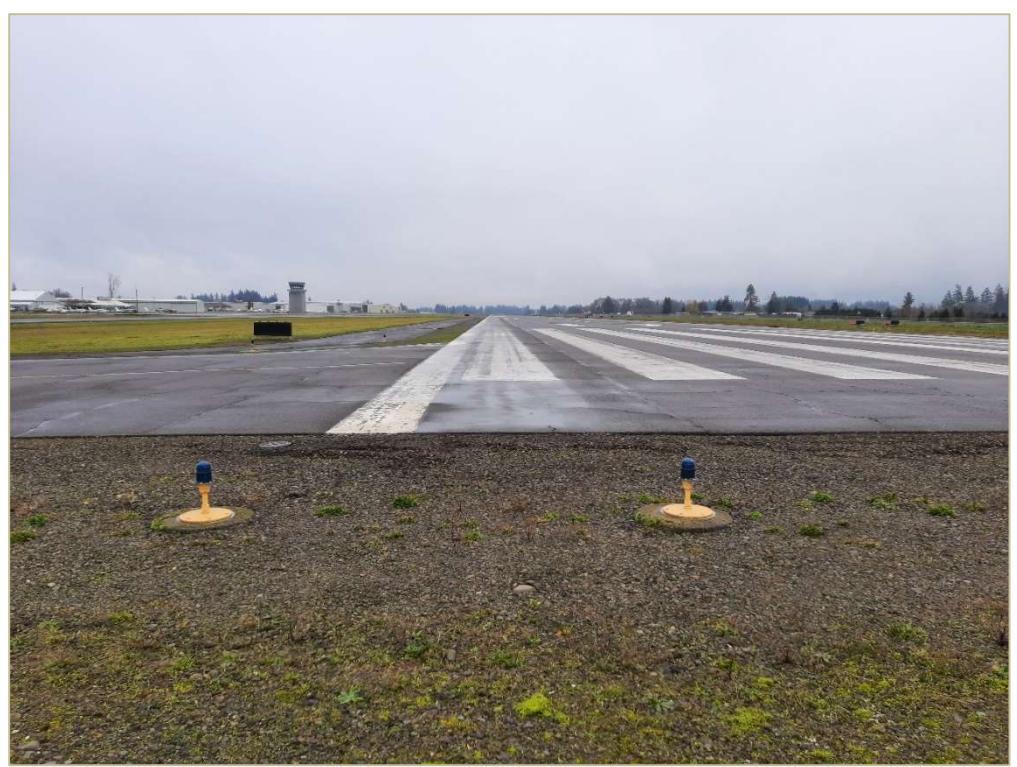
Photo 9. Overview from the north end of Runway 17/35, which was constructed in 1943. The view is towards the south.

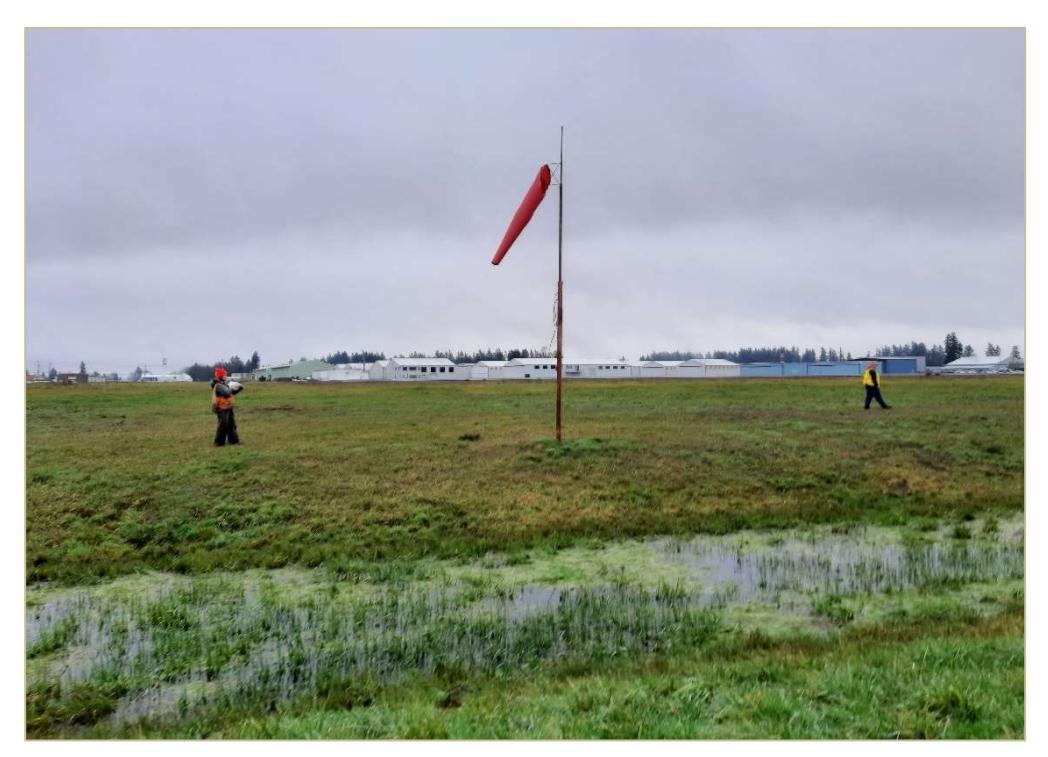
Photo 10. Circa 1953 wind cone and drainage ditch near the north end of Runway 17/35. The view is towards the east.
